## The Sawmill Creek Targeted Watershed Project

### BACKGROUND

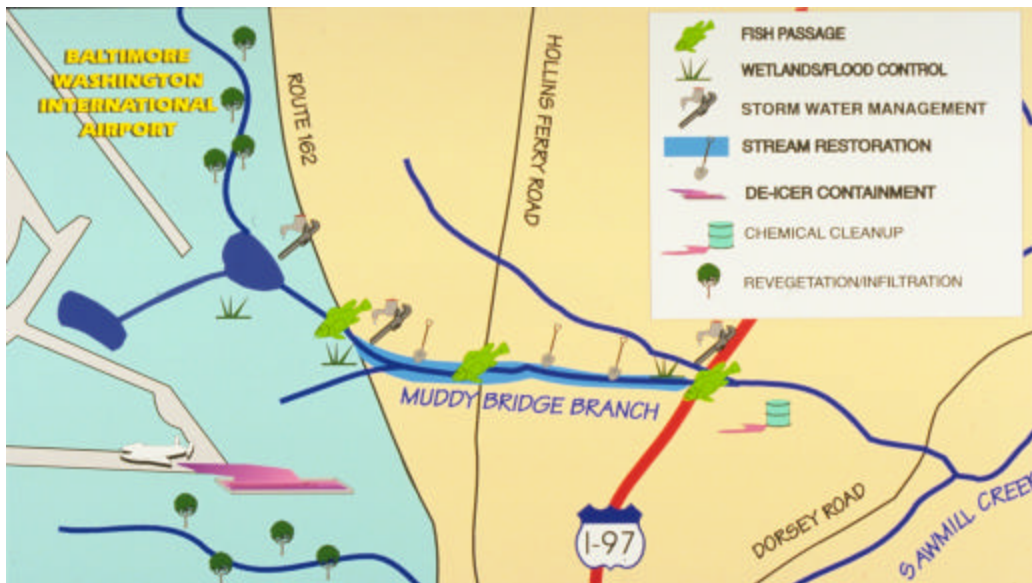
**Figure 5. Muddy Bridge Branch Restoration projects**

Some problems could be dealt with on an individual basis but others needed to be managed as an integrated system. Figure 5 illustrates how the project team is applying an ecosystem management approach to deal with the most impacted sub-basin in the watershed.

Starting at the top of this sub-watershed the following projects are being implemented in order to reduce the cumulative impacts of water quantity, water chemistry and habitat problems:

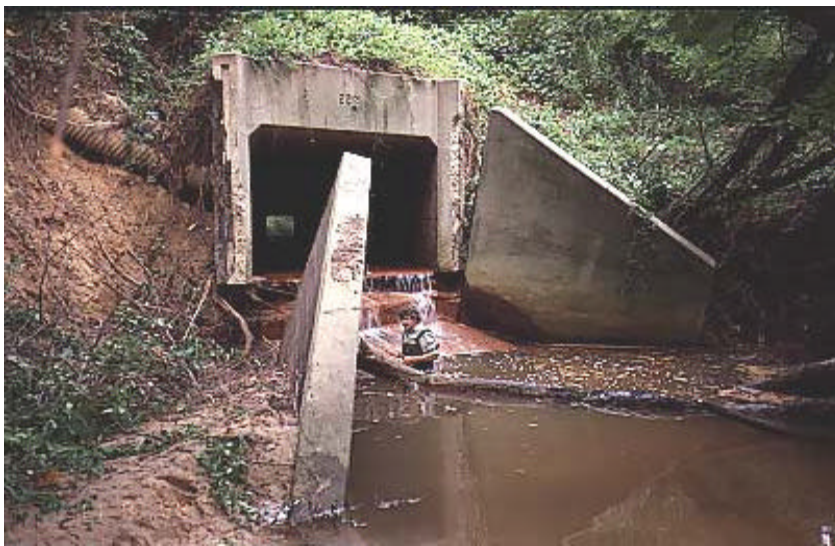
This section of Muddy Bridge Branch (MBB) was targeted for stream bank stabilization in 1992. The segment is approximately 1980 meters long with two complete fish blockages at the I 97 culvert (1.5 meter drop) and at the old Hollins Ferry road crossing (1.2 meter drop). Removal of the fish blockages was included in the stream restoration design package.

*Muddy Bridge Branch Stream Restoration Before Construction*

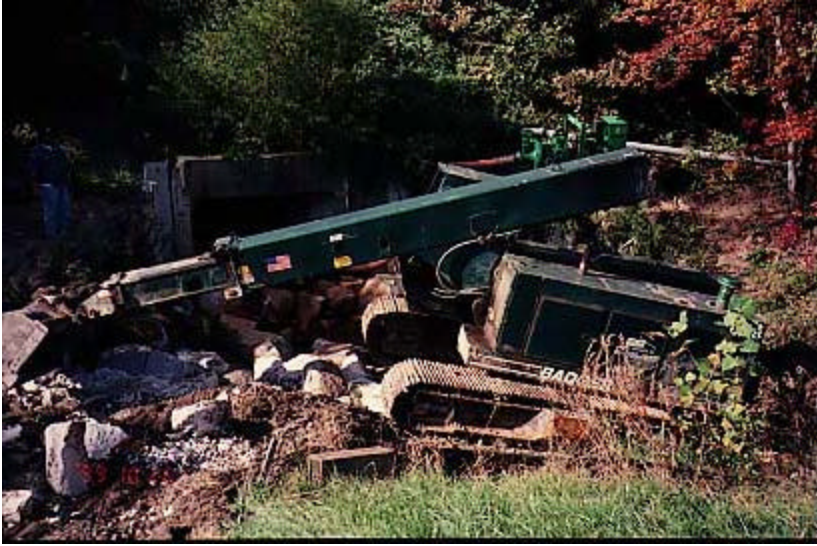
Stream restoration took place between September 1997 and January 1998. The Hollins Ferry Road crossing was removed and the culverts at the new Cromwell Blvd crossing were designed with a built-in low flow fish passage channel. A series of rock step pools had been designed to remediate the 1.5 meter vertical drop at the downstream end of the culvert. Construction of the step pools took place in several stages with the last work performed in Oct. 1999. To date, the step pools have not provided the target flow depth of 0.15 meters under base flow conditions. However resident fish have apparently been able to move up through the culvert under higher flow conditions, probably during the receding limb of storm flow events.

*Muddy Bridge Branch Stream Restoration Construction*
